Navajo Abandoned Uranium Mine

Site Screen Report

Mine Name: Monument No. 3
Mine ID: 226

April 2012

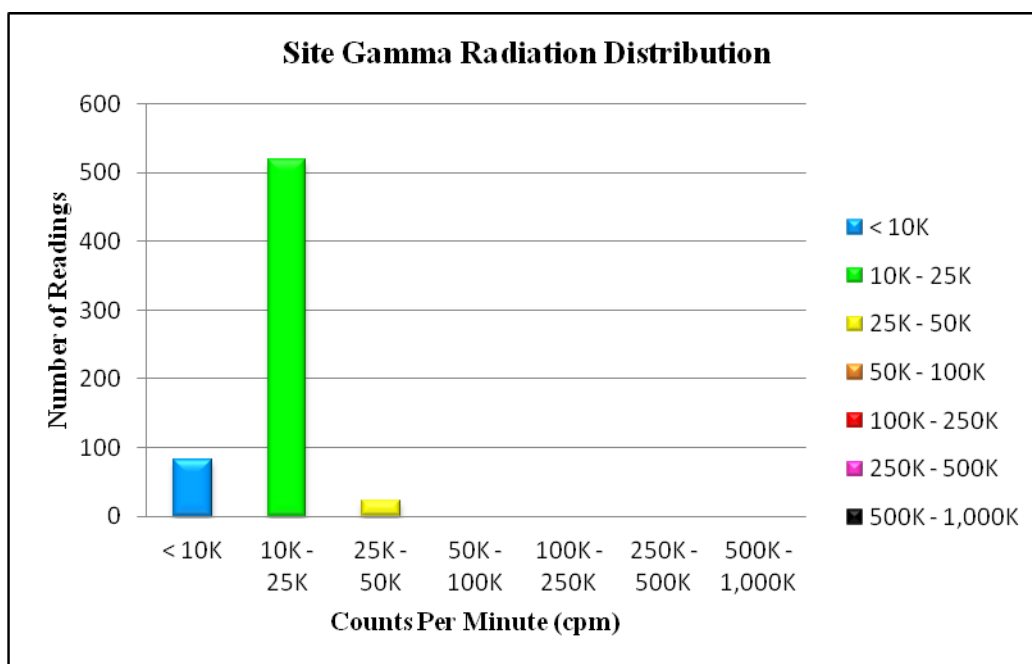
Distribution Chart and Statistics:

Site Gamma Radiation Statistics

Number of Readings	624
Minimum (cpm)	5,873
Maximum (cpm)	43,688
Mean (cpm)	14,550
Median (cpm)	13,927
Standard Deviation	5,119

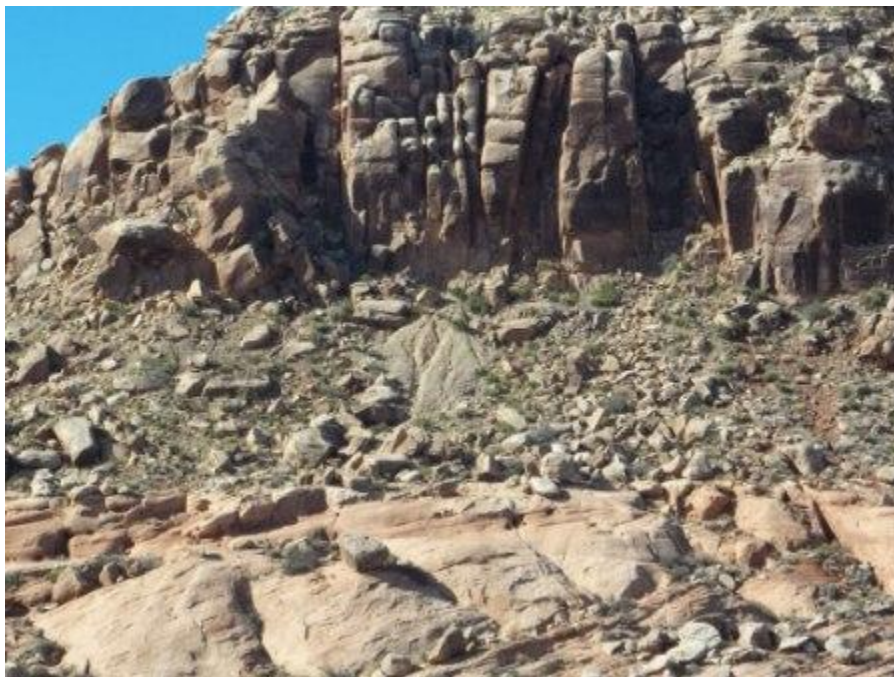
Photo 1

Mine Site #226

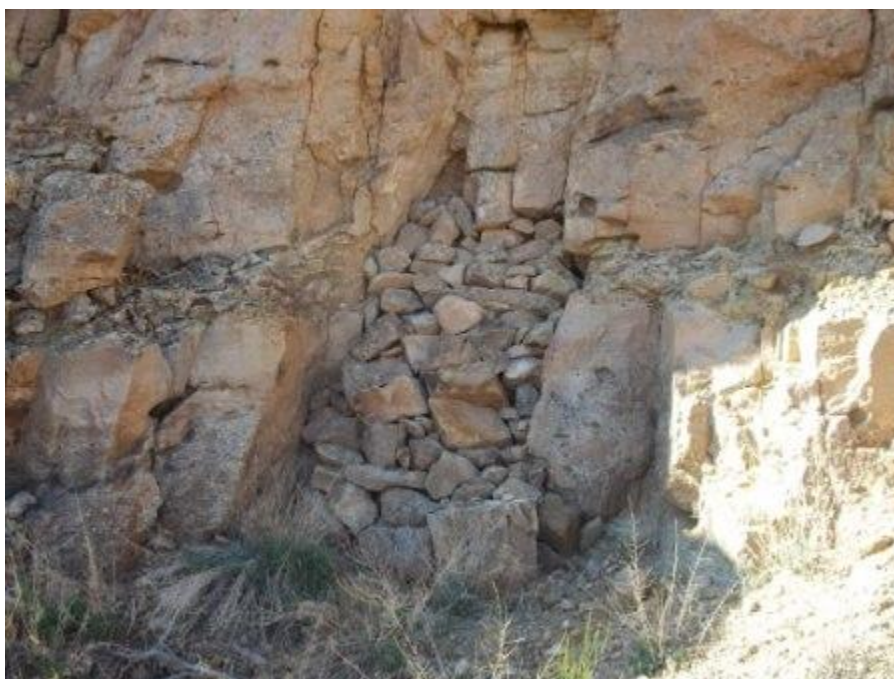
Photo 2

1 adit, stone sealed, approximately 7' x 5', alongside the hiking trail running through the site

Mine Site #226 - Adit

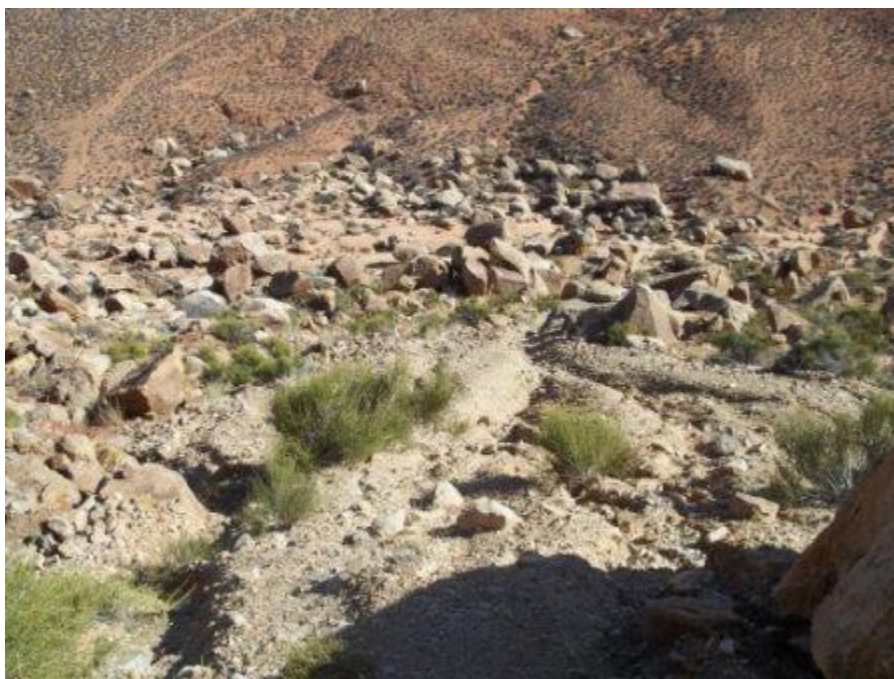
Photo 3

Waste rock/tailings below the adit, approximately 150' long x 60' wide

Mine Site #226 - Tailings

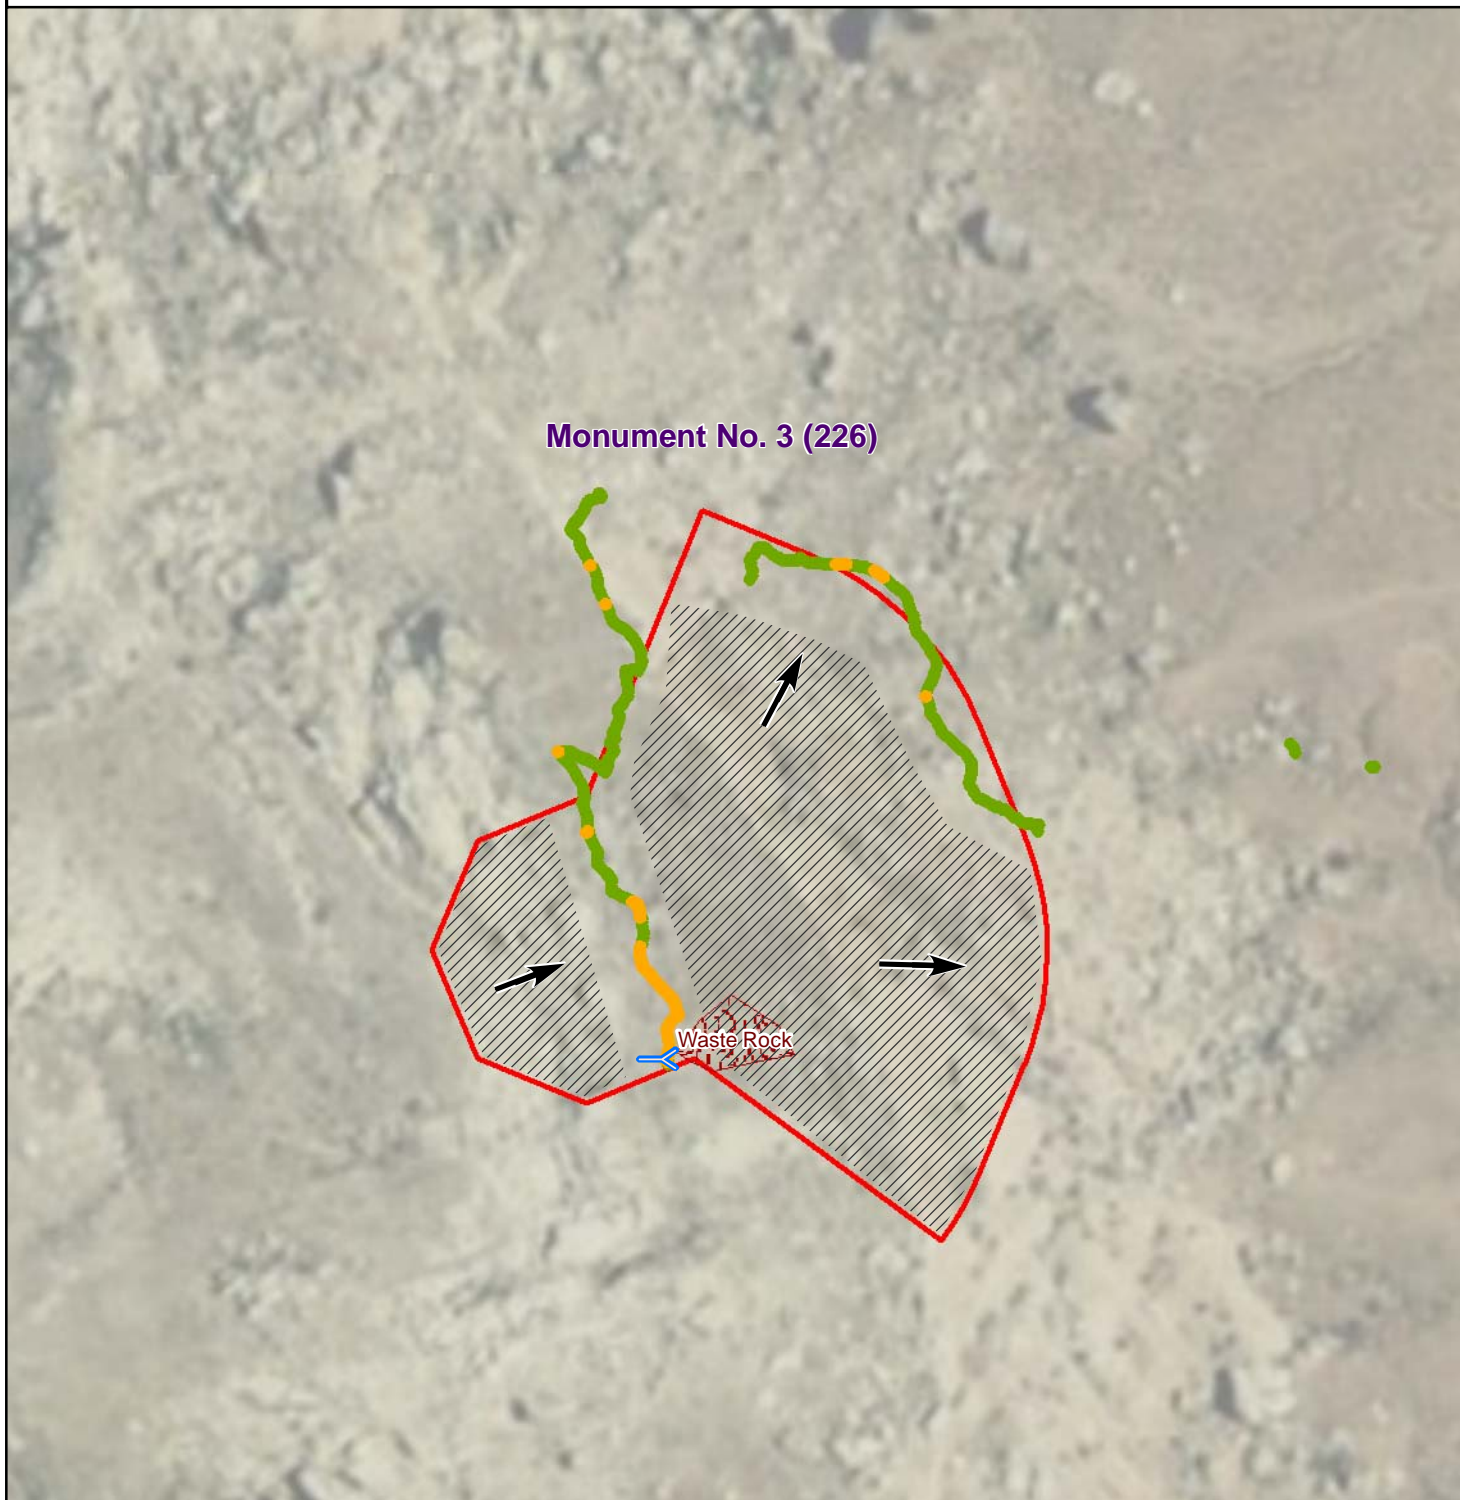
**Figure 1 - Gamma Radiation Measurements, Above Two Times Background
Monument No. 3 (226)
Oljato Chapter, Navajo Nation**

A total of 624 gamma radiation measurements were collected from the mine site, ranging from 5,873 cpm to 43,688 cpm. Maximum levels of approximately 45,000 cpm were found in the vicinity of the waste rock. The measurements are represented in Figures 1 and 2.

Measured as counts per minute (cpm)

Average background 9,058 cpm

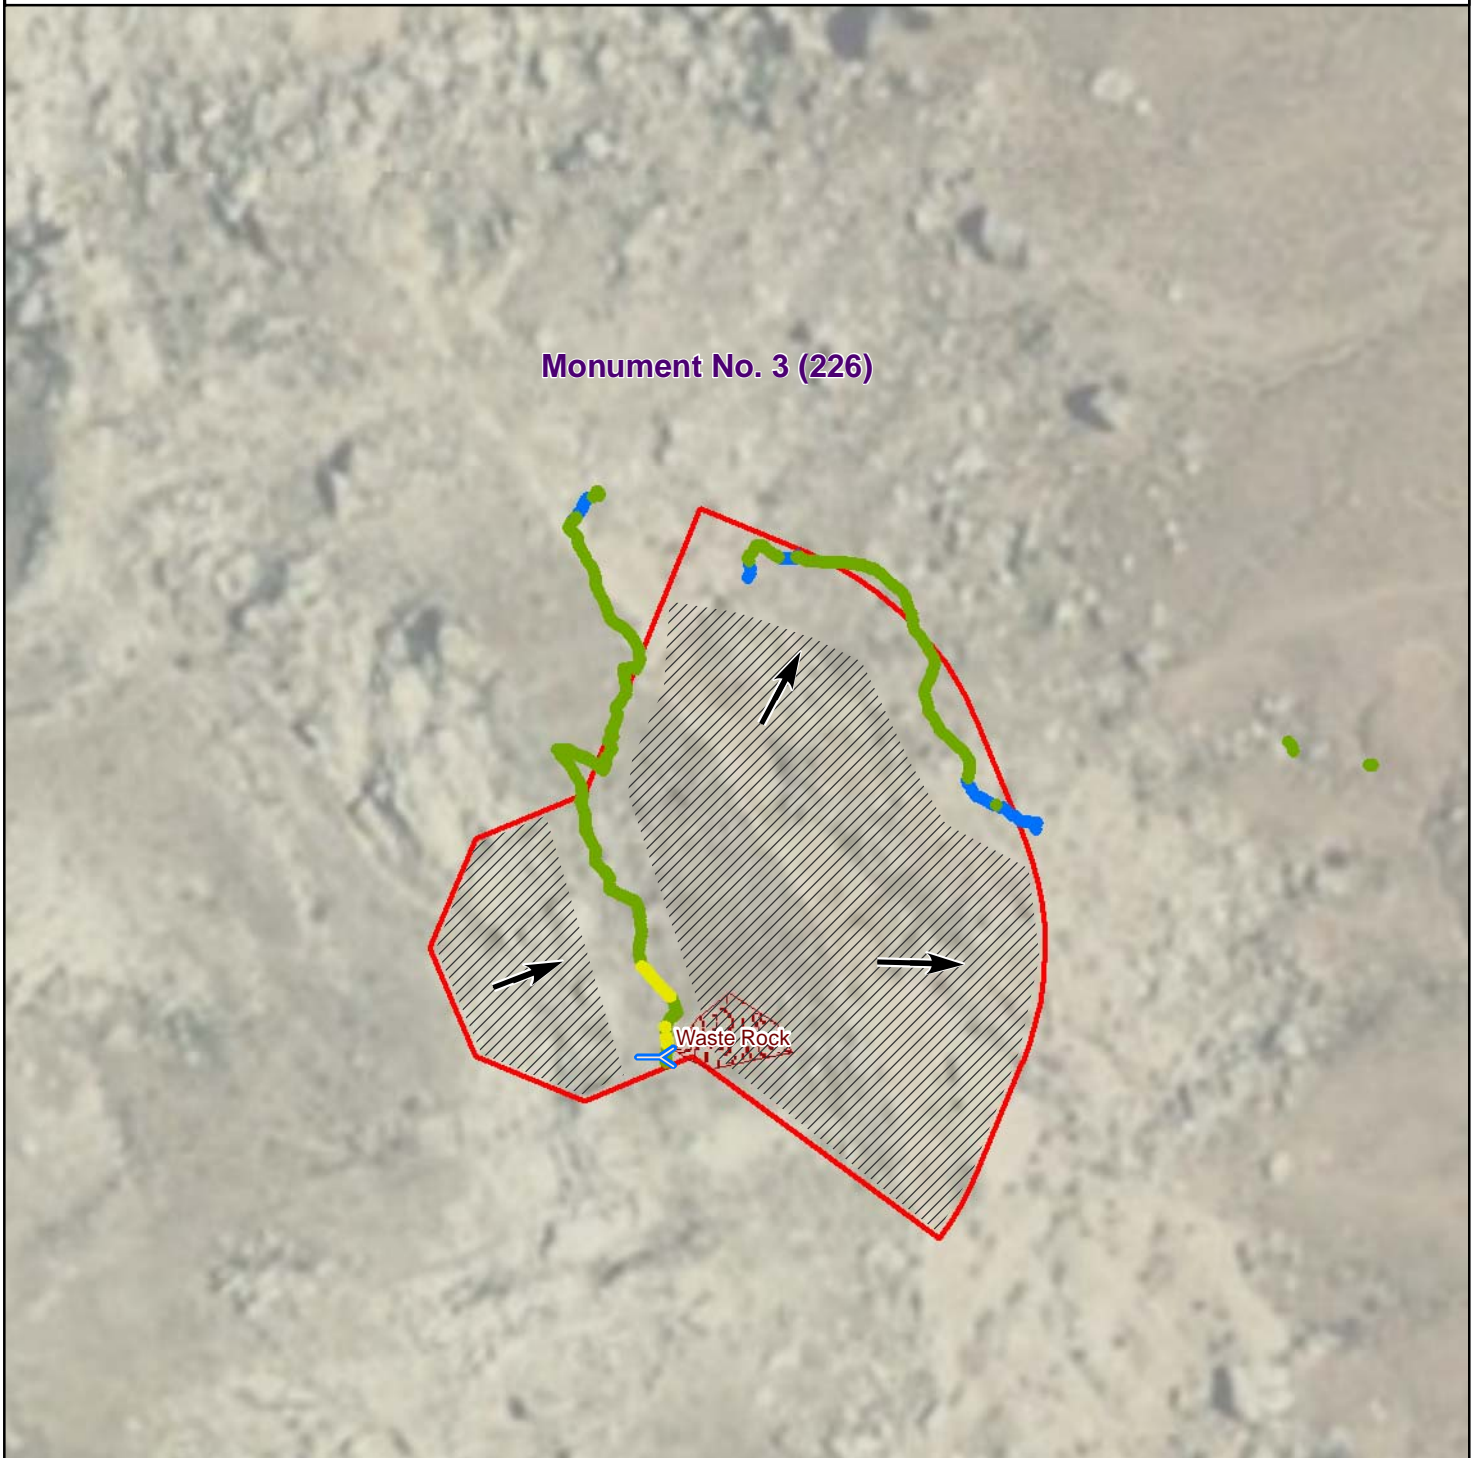
**Figure 2 - Gamma Radiation Measurements
Monument No. 3 (226)
Oljato Chapter, Navajo Nation**

Average background 9,058 cpm

Measured as counts per minute (cpm)
